**Technical Data Sheet**

Bridge Identification:	1510210000000B03
Facility Carried:	M 55
Feature Intersected:	Pine River
Location:	Norman Township
County:	Manistee
Region:	North
Year Built:	1934
Year Reconstructed:	1989, 1990
Bridge Type:	Cantilever Deck Truss
No. of Spans:	5
Deck Area:	24,249 S.F.
Paint System:	Type 4
Paint Area:	84,000 S.F.
Comments:	Historic Structure

### ***General Bridge Description***

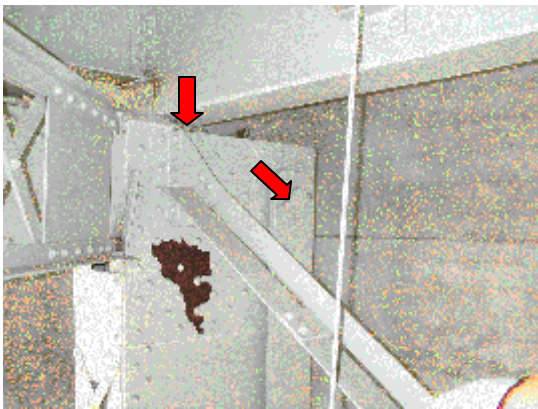
**! Tie-down members at abutments.** These pin and link assemblies (Photos 6 and 7) serve to anchor the trusses in Spans 1 and 3. They should be carefully inspected for cracks and loss of section and to ensure they are free to move as intended.

Typical Tie-down Top Pin at Abutment. Note Pack Rust between Floorbeam and Lateral Brace Gusset (6)

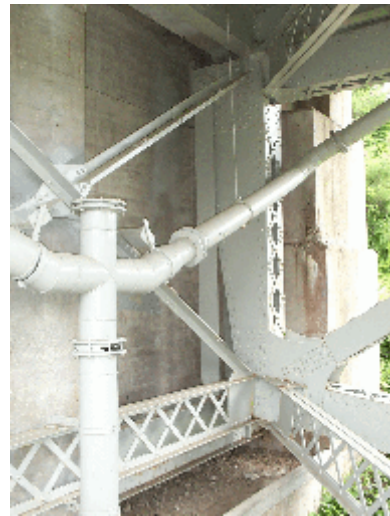
Overall View of Typical Tie-down (7)

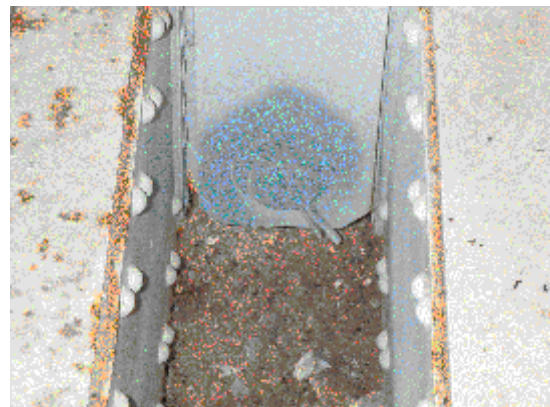
The bottom portion of the tie-down assembly is embedded in the abutment concrete. The resulting box configuration tends to accumulate dirt and debris that trap moisture. Check for corrosion and any associated section loss on these members at the abutment interface.

Typical Accumulation of Debris at Bottom of Tie-down (8)

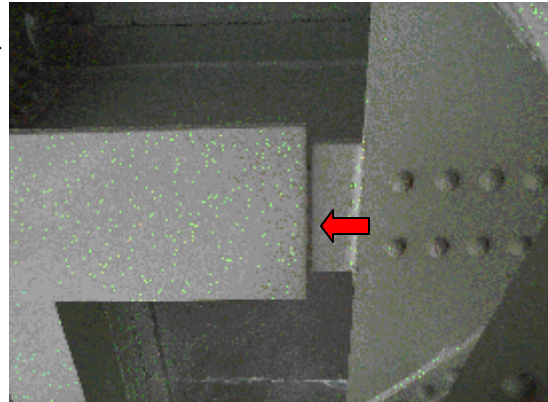
- ! **Welded cover plates on floorbeams.** These cover plates were added to the bottom flanges of the floorbeams during the rehabilitation. The terminations of the welds at the ends of the cover plates should be inspected carefully.

Typical Welded Bottom Flange Cover Plate (9)

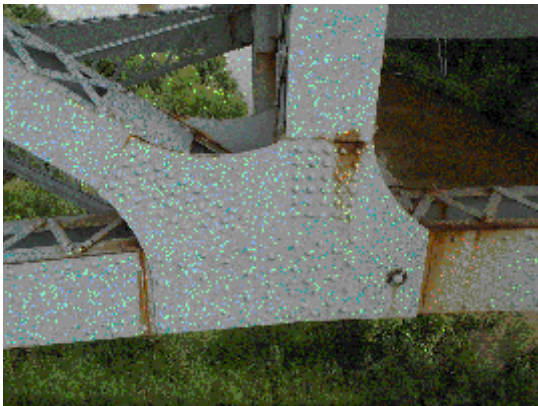
- ! **Truss Joints L10 and L12.** (Photos 10 and 11) The pins in the false chords at these locations in both trusses were replaced during the rehabilitation because of extensive saw-cutting action from the chords. The new pins should be monitored for similar problems. Also, the gusset plates on both trusses should be examined for surface rust and any associated section loss and pack rust between plates. These areas should be monitored closely.

Typical Lower Chord Gusset Plate (10)

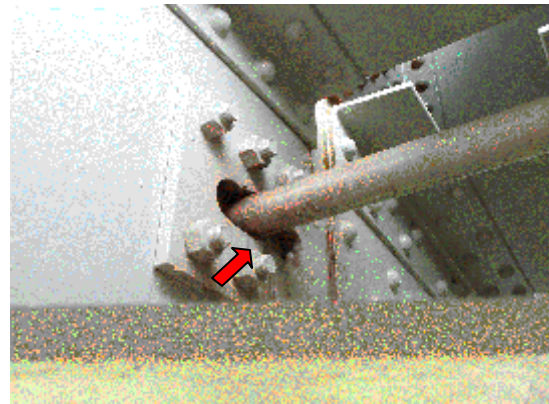
Worn False Chord Pin Slot. L10 North shown.  
Note that Pin is in Contact with Pin Plate. (11)

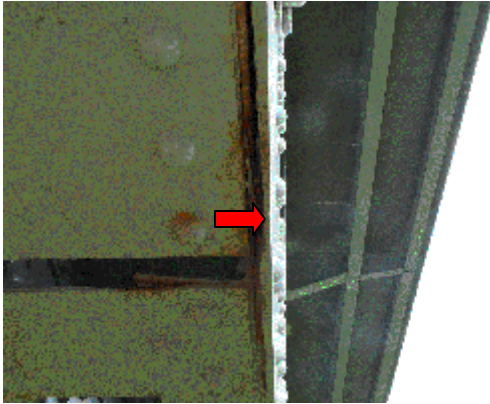
- ! **Truss Joints.** (Photos 12 and 13) The truss joints are made up of large gusset plates that connect the truss members. These joints, with their layers of plates, are susceptible to development of pack rust or crevice corrosion. The joints should be inspected closely for pack rust formation and associated loss of section in the gusset plates or members. The gusset plates on the suspended span truss joints and the pins should be inspected for proper alignment and clearances and for possible wear caused by their rubbing together under live load.

Section Loss at Truss Joint Gusset Plate (12)

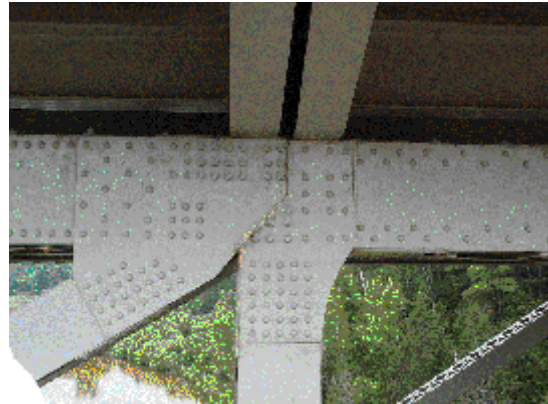
Typical Upper Chord Gusset Plate (13)

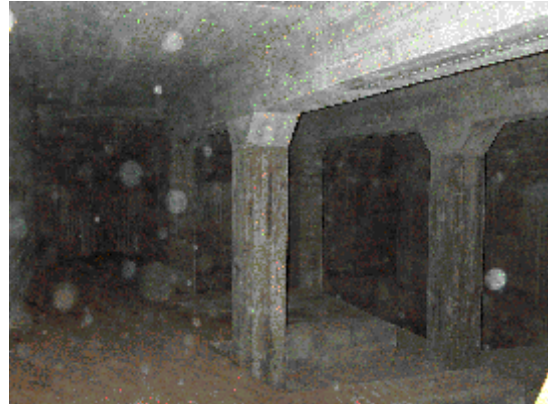
These spans are accessible through manholes in the sidewalks at either end of the bridge or through doors in the abutment backwalls. These areas qualify as confined spaces and appropriate safety procedures should be followed. The concrete should be inspected for cracking, spalling, and general condition.

Tee Beam End Span (14)

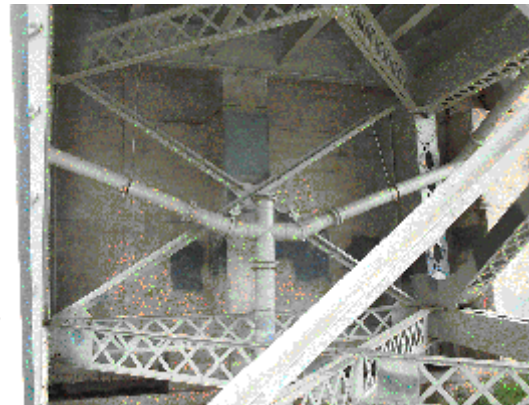
- ! Drainage systems at abutments.** The drainage systems at the abutments are a potential maintenance problem. There are several bends and changes in direction of the downspouts, which can lead to accumulation of debris inside the pipes. Also, check for erosion, which may indicate a leak in the system.

Drainage System at East Abutment (15)

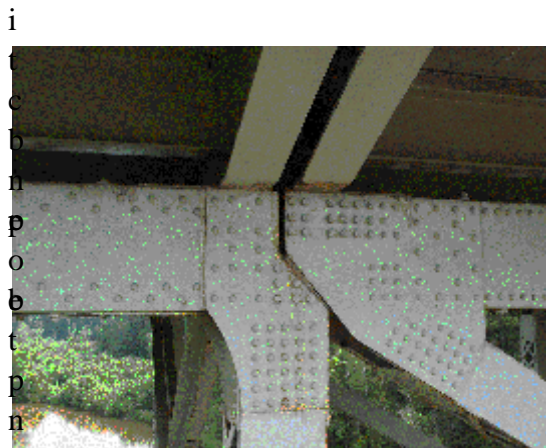
- ! Joints U10 and U12.** (Photos 16 and 17) The floorbeams at these locations are framed closely

South Top Chord at U10 (16)

ss are enclosed in box members at this location. These areas should be carefully inspected for development of corrosion and section loss.

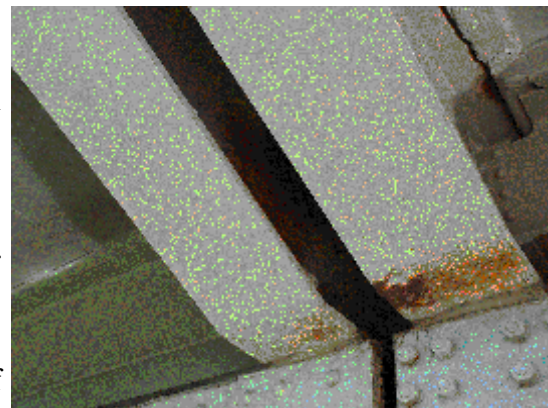
Rusted Floorbeam at U10, South Side (17)

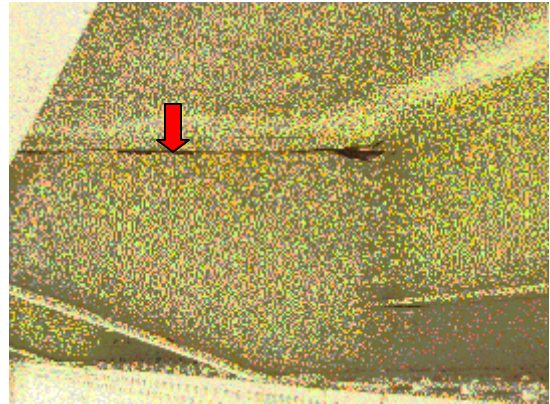
- ! **Floorbeam top flanges.** The cold joints in the deck are susceptible to leaking, allowing corrosion to form on the top flanges of the floorbeams. These flanges should be monitored for deterioration.

Typical Rust on Top Flange of Floorbeam at Leaking  
Cold Joint (18)

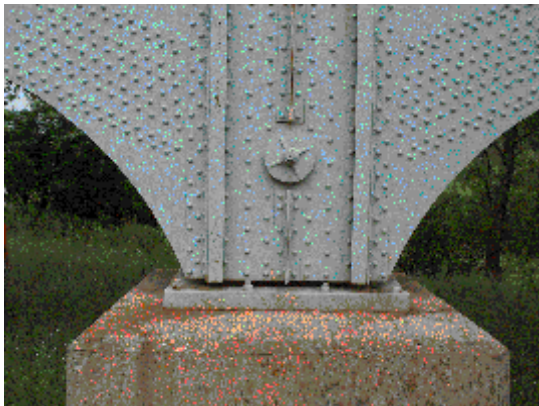
- ! **Truss bearings at piers.** Inspect the truss bearing assemblies (Photos 19 and 20), especially the pins, at the piers for signs of unusual wear or cracks. Inspect to ensure they are free to move as intended.

Typical Truss Bearing at Pier - Elevation View (19)

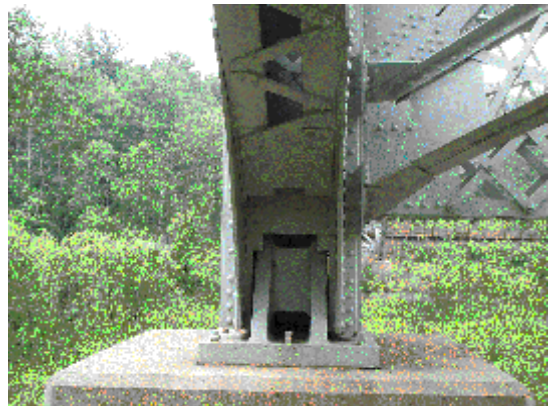
Typical Truss Bearing at Pier - End View (20)
